EXCAVATION AND REPAIR OF SUN TEMPLE MESA VERDE NATIONAL PARK

DEPARTMENT OF THE INTERIOR
OFFICE OF THE SECRETARY
1916

By J. WALTER FEWKES, *Bureau of American Ethnology.*

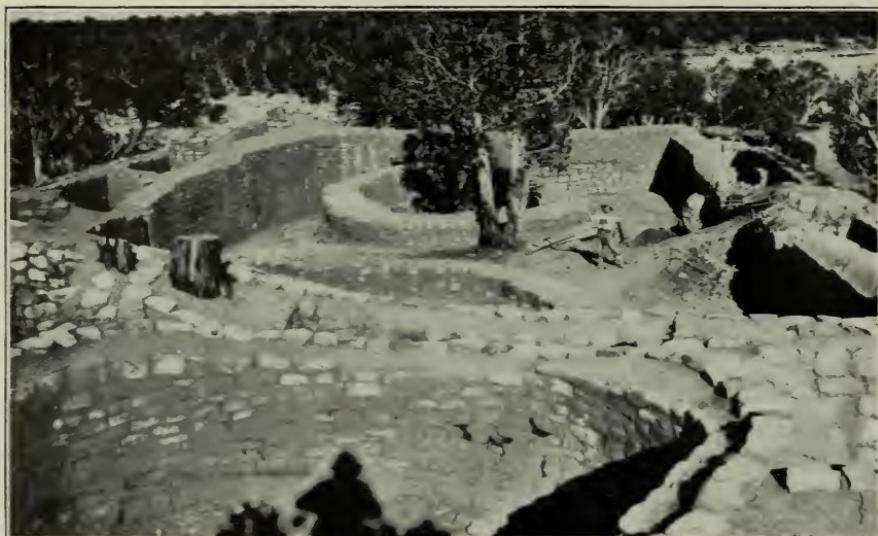
FIG. 5.—INTERIOR OF RUIN, LOOKING EAST. SHOWING CEDAR STUMP.

shown as on the facing of the outer walls. Roots of trees formerly growing on the ruin have made their way between the courses of stone and can still be seen in the walls.

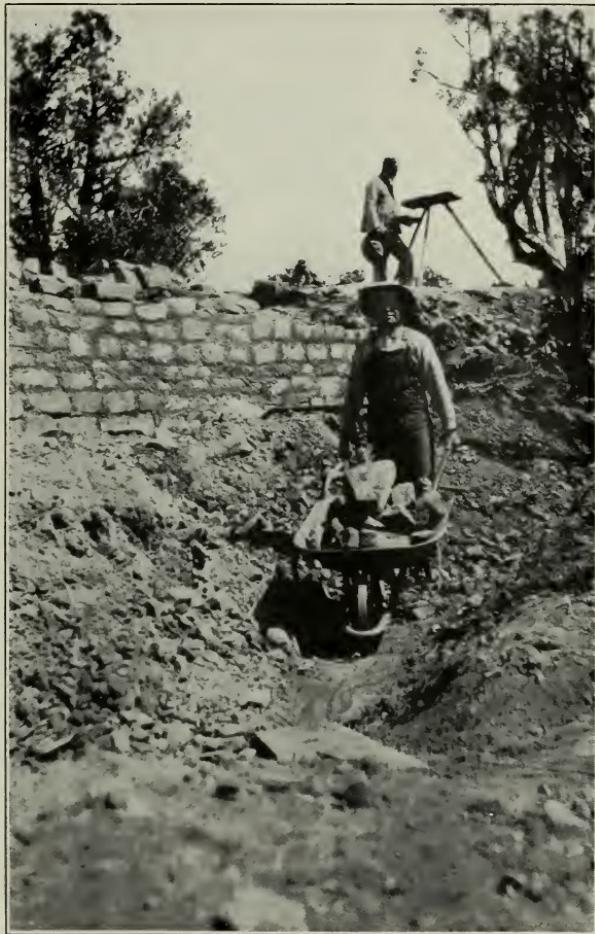
The stones out of which the walls were constructed were quarried on the mesa top near the ruin and are of the same sandstone as the cliff. They vary in size and in degree of hardness, some specimens being so soft that their surfaces may be rubbed off by hand. On account of the softness of these rocks it was not a difficult feat to fashion them into shape; a few blocks were dressed into perfect cubes, their faces being at right angles. There was an attempt to lay stones of the same thickness in the same course, but often lines of thick stones alternated with stones half as large (fig. 6). Stones were blocked into shape by cutting grooves on opposite faces and

FIG. 6.—SOUTH WALL, LOOKING WEST.

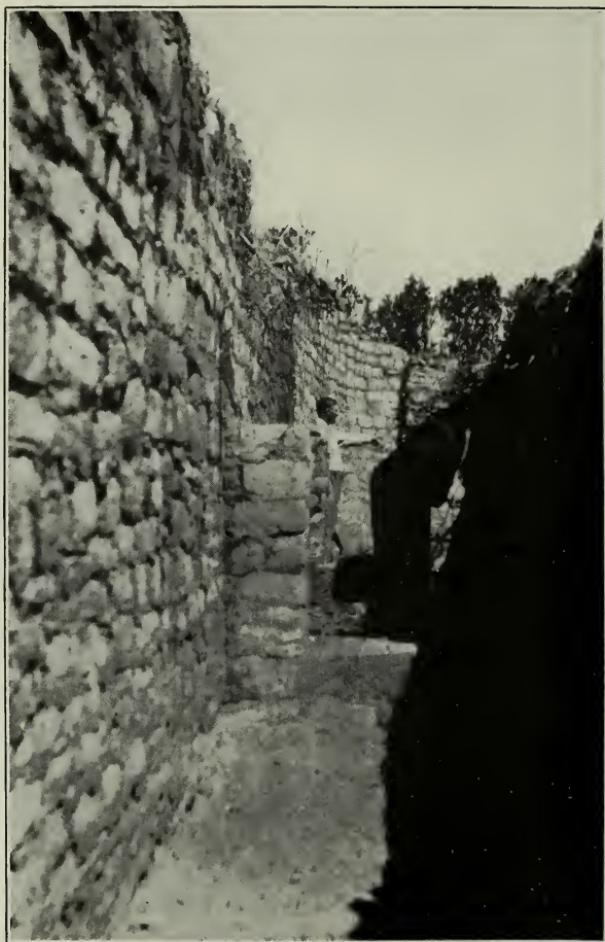
FIG. 8.—WEST WALL OF ROOMS *d* AND *e*, SHOWING DOORWAY.

t-v. The lintels which remained were much decayed and sagged under the weight of the wall above them, so much so that a brace of modern construction was introduced to support them. The lintel that held up the covered doorway of room *r* and that which supported the floor of room *z* above the trench leading into kiva A, were partially intact, but most of the lintels had to be replaced by modern beams, the originals being much decayed (fig. 8).

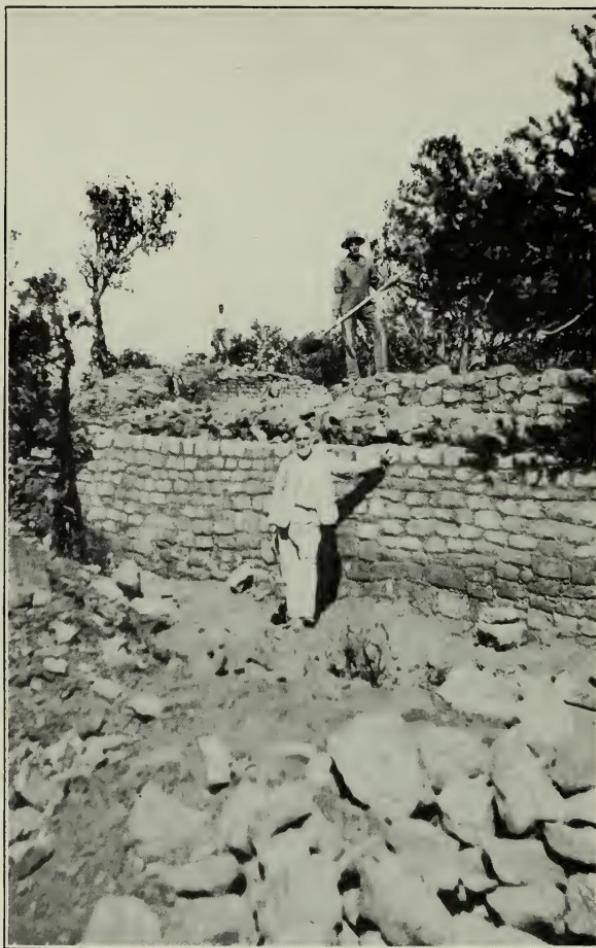
The main causes of destruction of this ruin were not vandals, as at Cliff Palace, but the elements, especially water. After it was abandoned the tops of the walls were exposed to the sky and unprotected either from snow or rain which sometimes falls in torrents. The snow was particularly damaging, for the water from the melting snow percolated between the facings and the core of the wall, and subsequently froze, forcing the facing of the wall away from the central core until it fell. That this was the main cause of deterioration is shown by the fact that as a rule the outer facing of the surrounding wall was more nearly obliterated to a lower level than the inner, and as a rule the core projected often a foot above faces of the wall. The deleterious cause which early led to the overtopping and destruction of walls would be even more potent when they were excavated. Some means had to be devised to prevent a continuation of their destruction (fig. 11).

FIG. 11.—PART OF SOUTH WALL, PARTLY EXCAVATED.

Although the walls of the building were so massive that they remained intact to the height of the top of the mound, they were partially held up by an accumulated débris. The removal of earth and fallen rocks weakened them so much that some provision had to be made to counteract this loss of support. In order to prevent the

water from melting snow from penetrating the walls, or the rain from percolating between the core of the wall and its facing, I placed a cap of cement on the tops of all the walls. The inner facing of the outer walls, as a rule, stood a few courses of stone higher than the outer, and it was necessary to add masonry to bring the outer wall to the level of the core and inner facing. Having leveled the top of

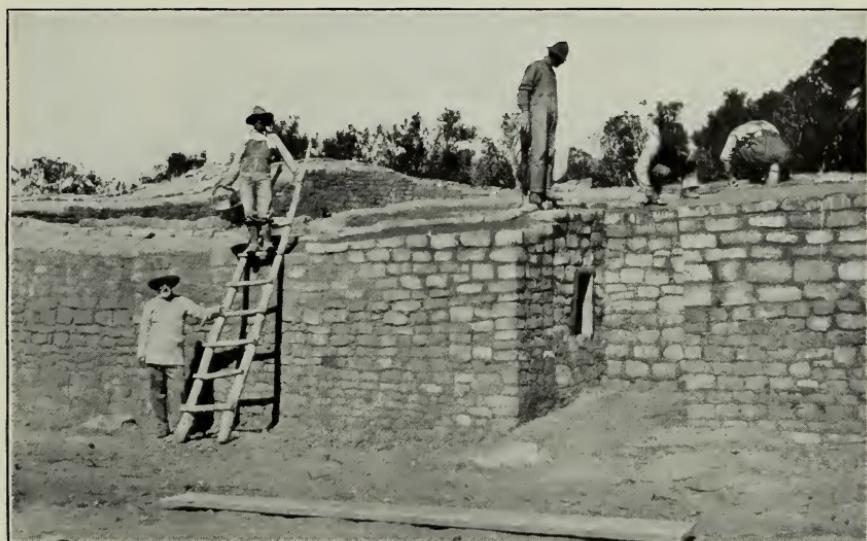
FIG. 12.—CEMENTING WALL OF RECESS IN SOUTH WALL.

the wall, I covered it with small, angular fragments of stone, placing these fragments highest in the middle or over the core. Over this roof-like covering was spread a thick layer of adobe. The top of the wall was thus made in a way to shed water. Over this roof of adobe was spread a layer of Portland cement, 2 inches thick, mixed in proportion of 1 to 5, care being taken to use this cement freely in point-

ing the joints in the facing of the wall in order to prevent the entrance of water in the cracks (fig. 12). The roof shape of this covering or the fact that it is highest in the middle will shed the water and throw it away from the wall without harm. The layer of cement protects the adobe used in pointing the walls and prevents it from being washed from between the stones. Direct action of rain beating on the surface or outside of the wall could not be prevented in this way.

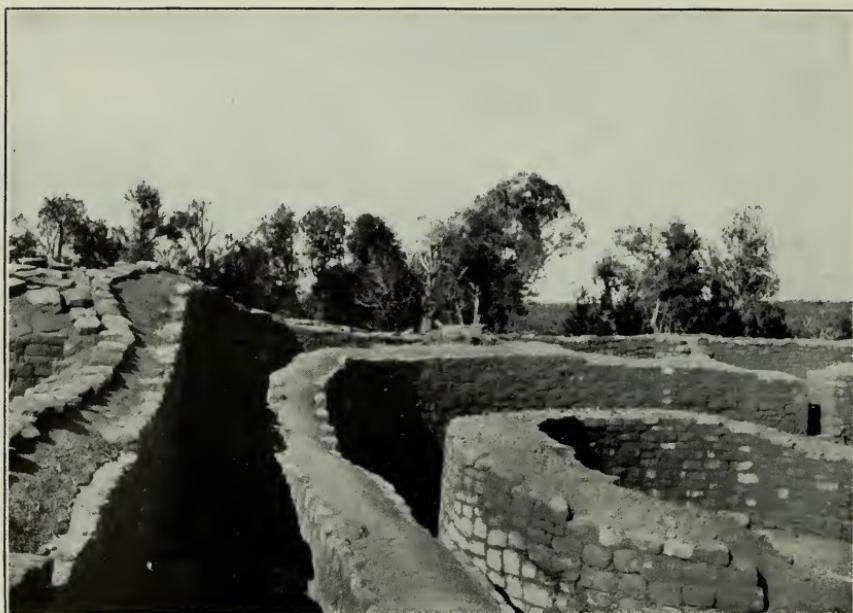
FIG. 13.—WEST ROOMS OF ORIGINAL BUILDING.

wearing away of the cement by anyone who desired to walk on top of the walls, a row of stepping stones (fig. 13) firmly set in place was provided.

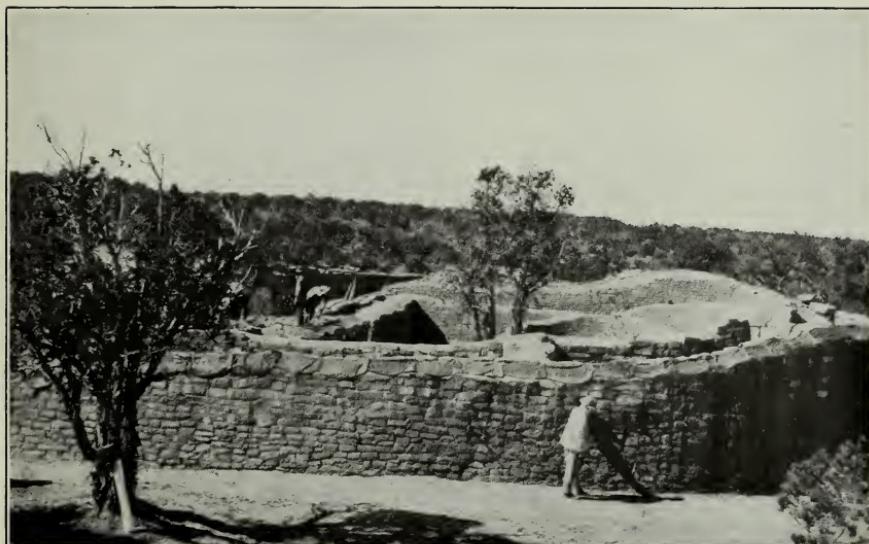
FIG. 15.—OUTER NORTHEAST WALL.

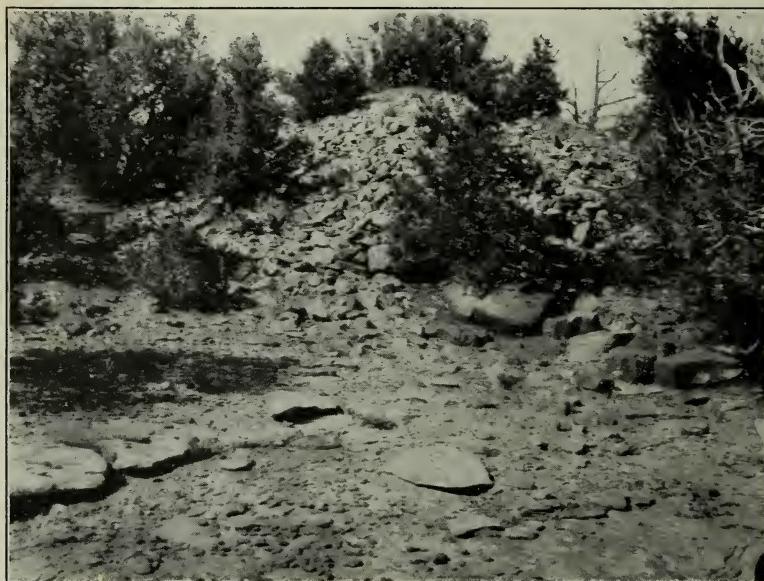
FIG. 17.—SUN TEMPLE, BEFORE EXCAVATION, FROM NORTHEAST.
